NASA Contractor Report 4664

# Analysis of Materials Flown on the Long Duration Exposure Facility: Summary of Results of the Materials Special Investigation Group

*H. Gary Pippin*

*H. Gary Pippin*  
*Boeing Defense & Space Group • Seattle, Washington*

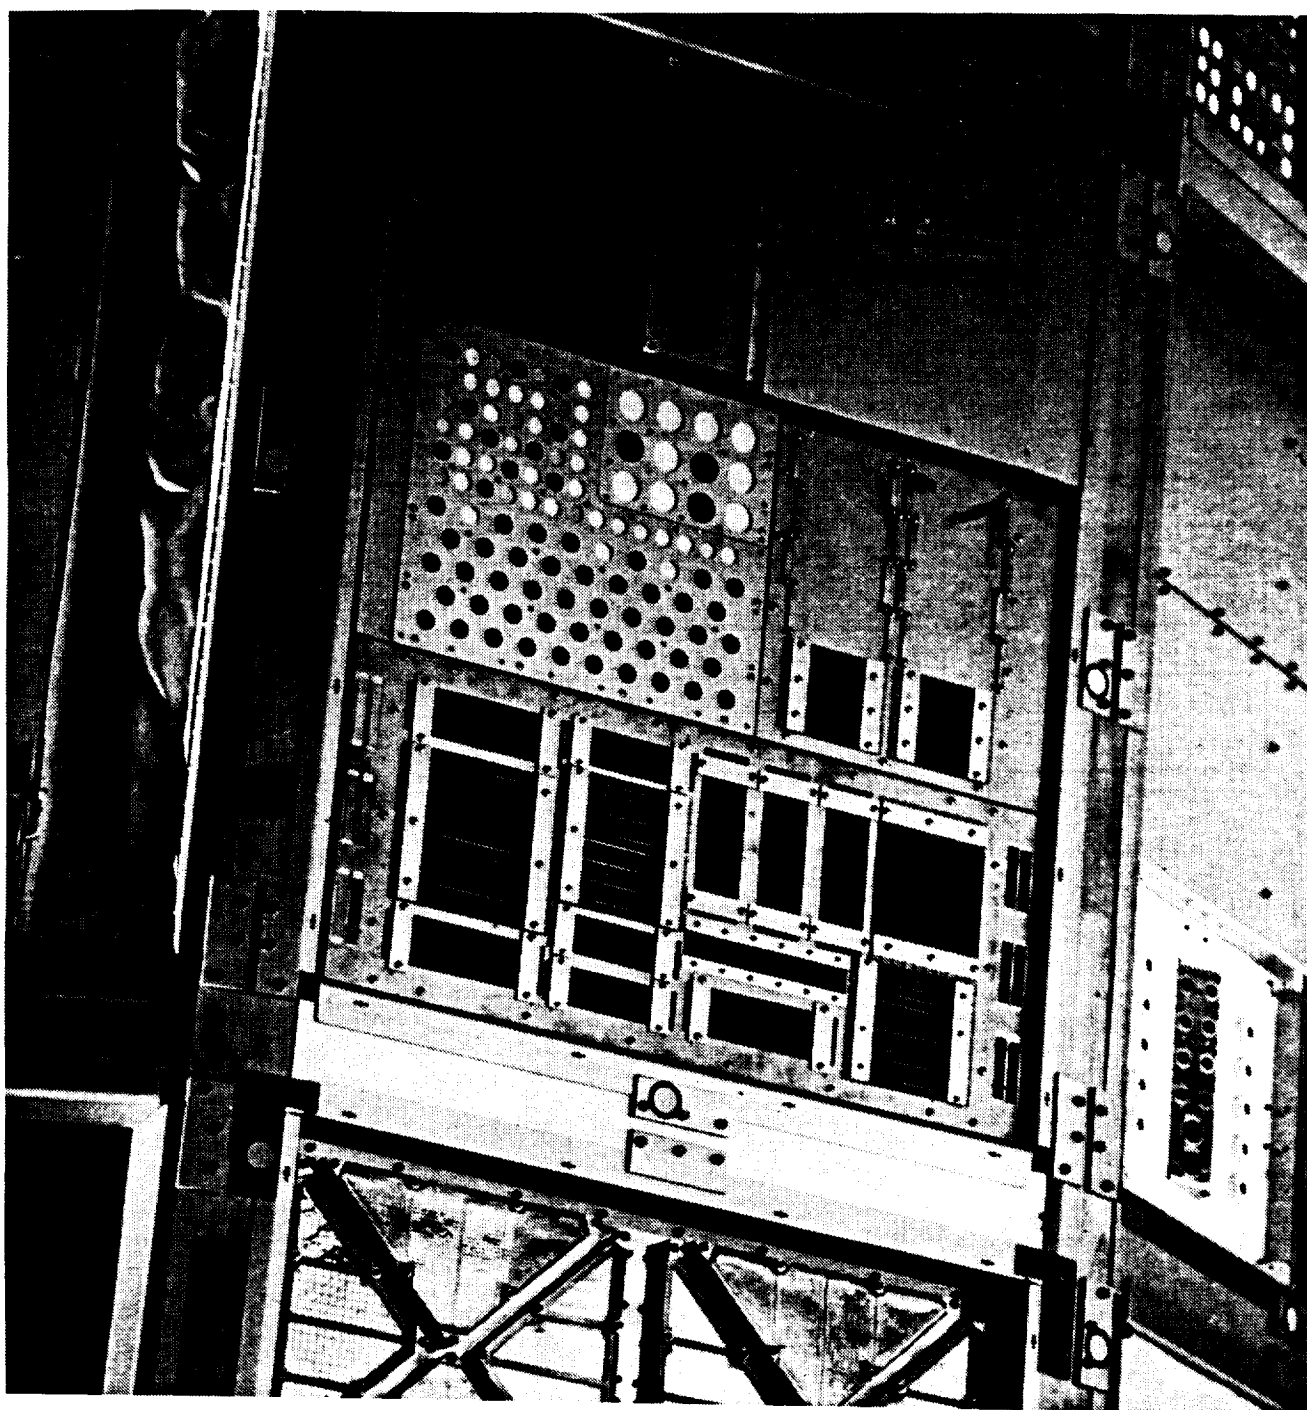
Because the EECC's were opened for the first 10 months of the mission, the specimens in the leading edge canisters received relatively small doses of atomic oxygen. Similarly the solar exposure levels were also small fractions of the mission totals for these rows. Figure 7.1-5 also shows the exposure levels for each EECC during the time period they were open, from day 10 to day 297 of the mission. The M0003 canisters on rows 4 and 8 were opened in stages, starting at the 10 day mark with a partial opening, further opened 9 weeks later, and finally completely opened at 19 weeks. For the canisters which opened in stages, the visual appearance of the three areas of differing exposure level was quite different, with the area of maximum exposure being the most discolored. This is consistent with rapid outgassing of material in the first several weeks of the mission, followed by UV fixing when the material redeposits on a surface. The lighter color of the other areas is due to decreased outgassing at the time which these surfaces were exposed.

Figure 7.1-4. NASA on-orbit photo of experiments on tray B9, including the closed EECC. (Color figure C-5)

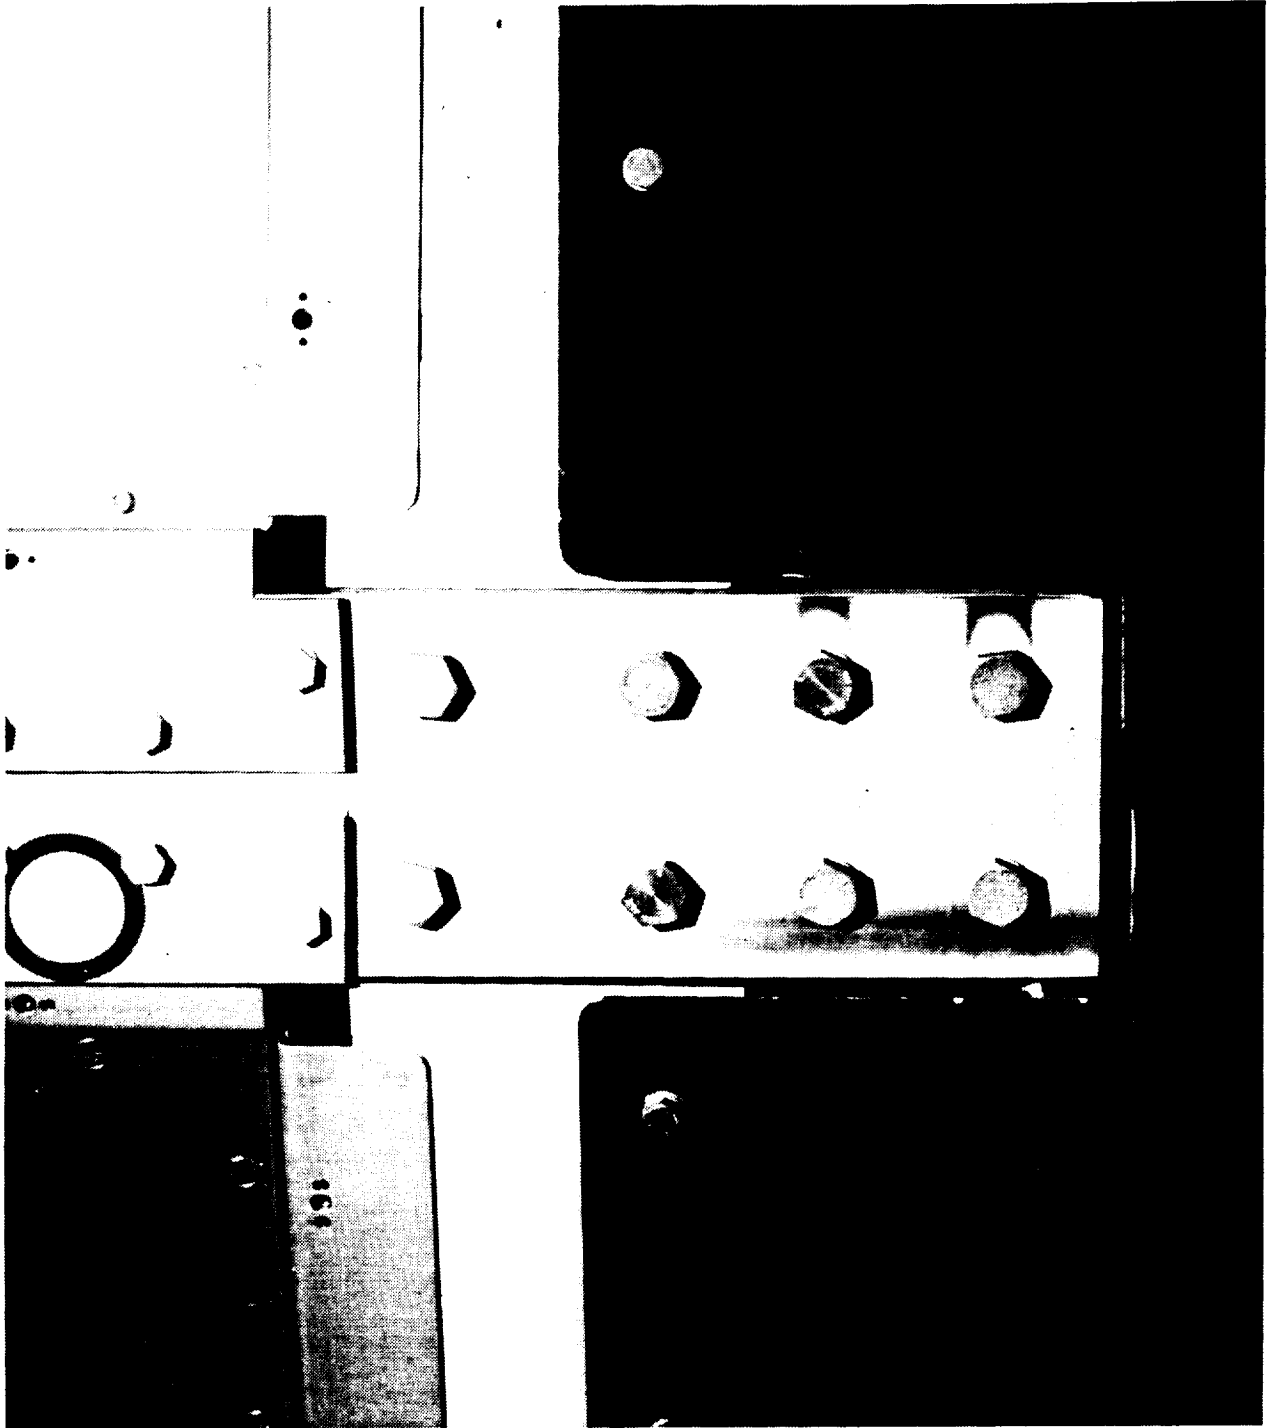
Figures 7.2-4 and 7.2-5 are photos showing near Earth-end vent locations between rows 11 and 12, and rows 7 and 8, respectively. The photos in these figures show essentially the same contamination patterns as figures 7.2-2 and 7.2-3, respectively. It is clear that the end-of-flight patterns are the result of multiple, sequential processes, including initial venting and outgassing, deposition on the surfaces, thermal cycling, and discoloration due to the environmental exposures. The three-dimensional details influence the deposition pattern through the geometry of the vent path, reflections from, and shielding by, the bolt heads, and the elevation of the black anodize aluminum structure above the longeron surface.

Figure 7.2-4. NASA post-flight photo of contamination deposits on longeron between trays A11 and A12. (Color figure C-15)

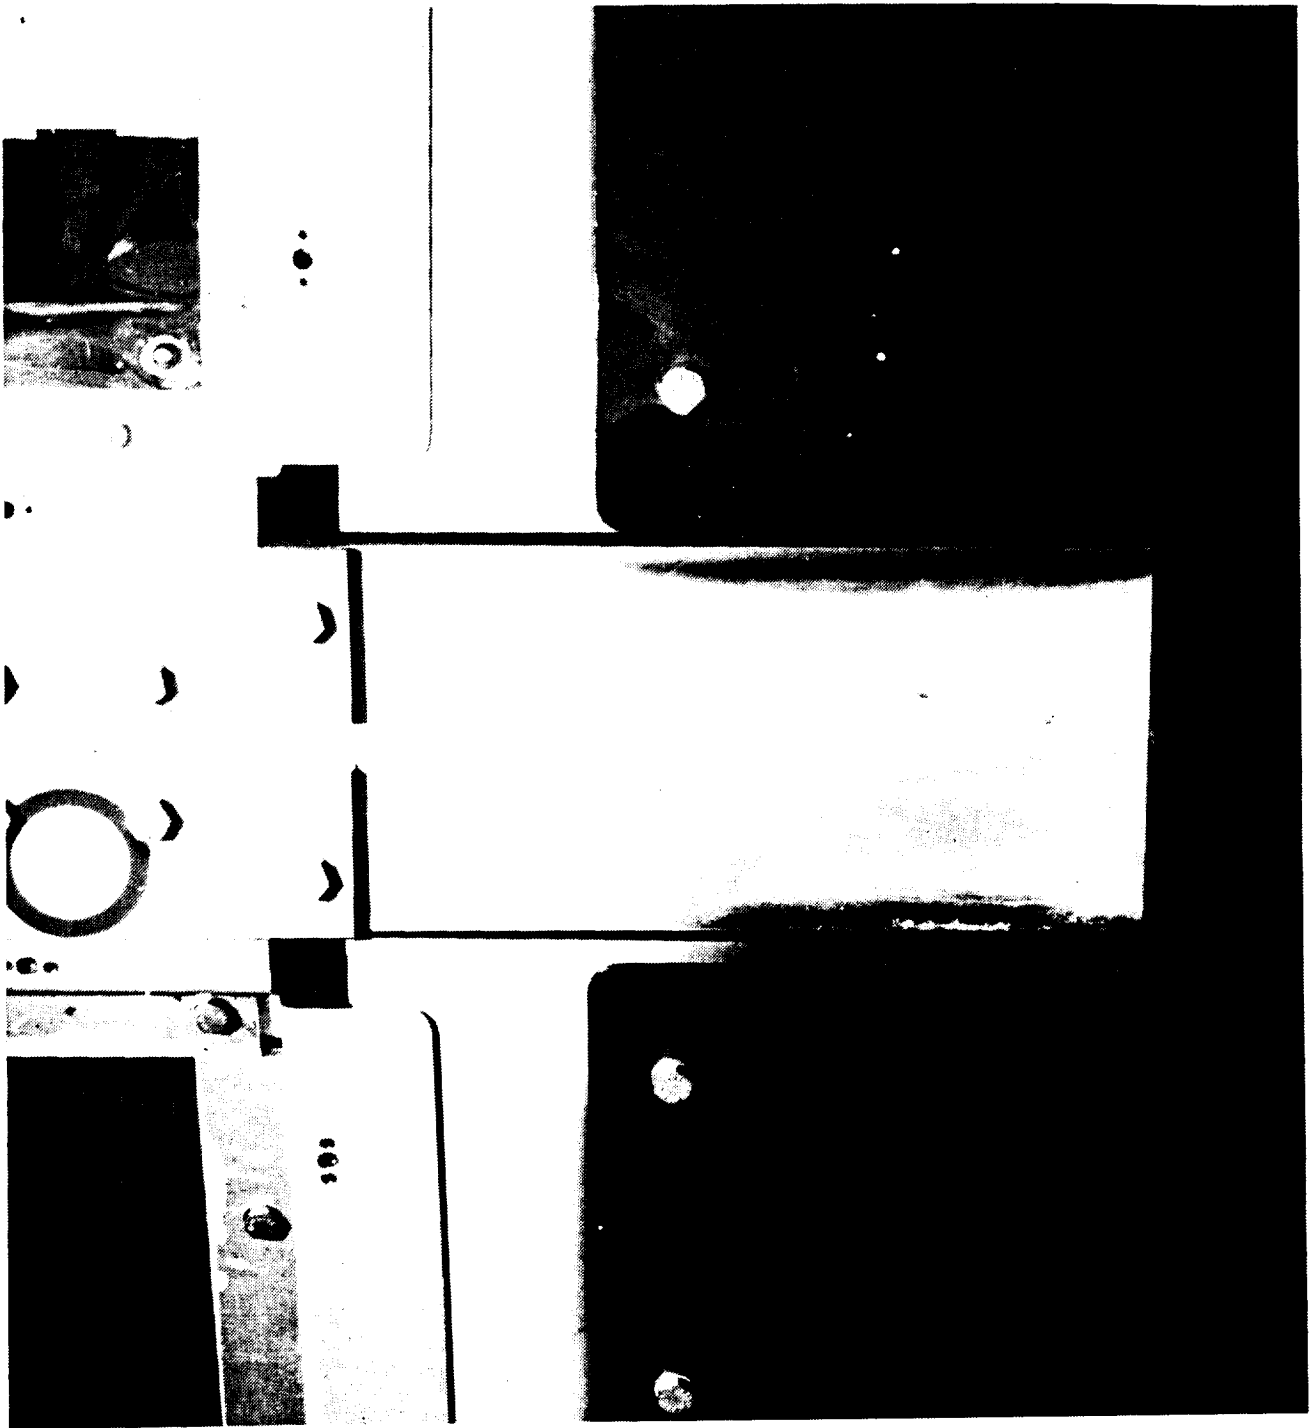
Figure 7.2-5. NASA post-flight photo of contamination deposits on longeron between trays A7 and A8. (Color figure C-16 rotated 90°)

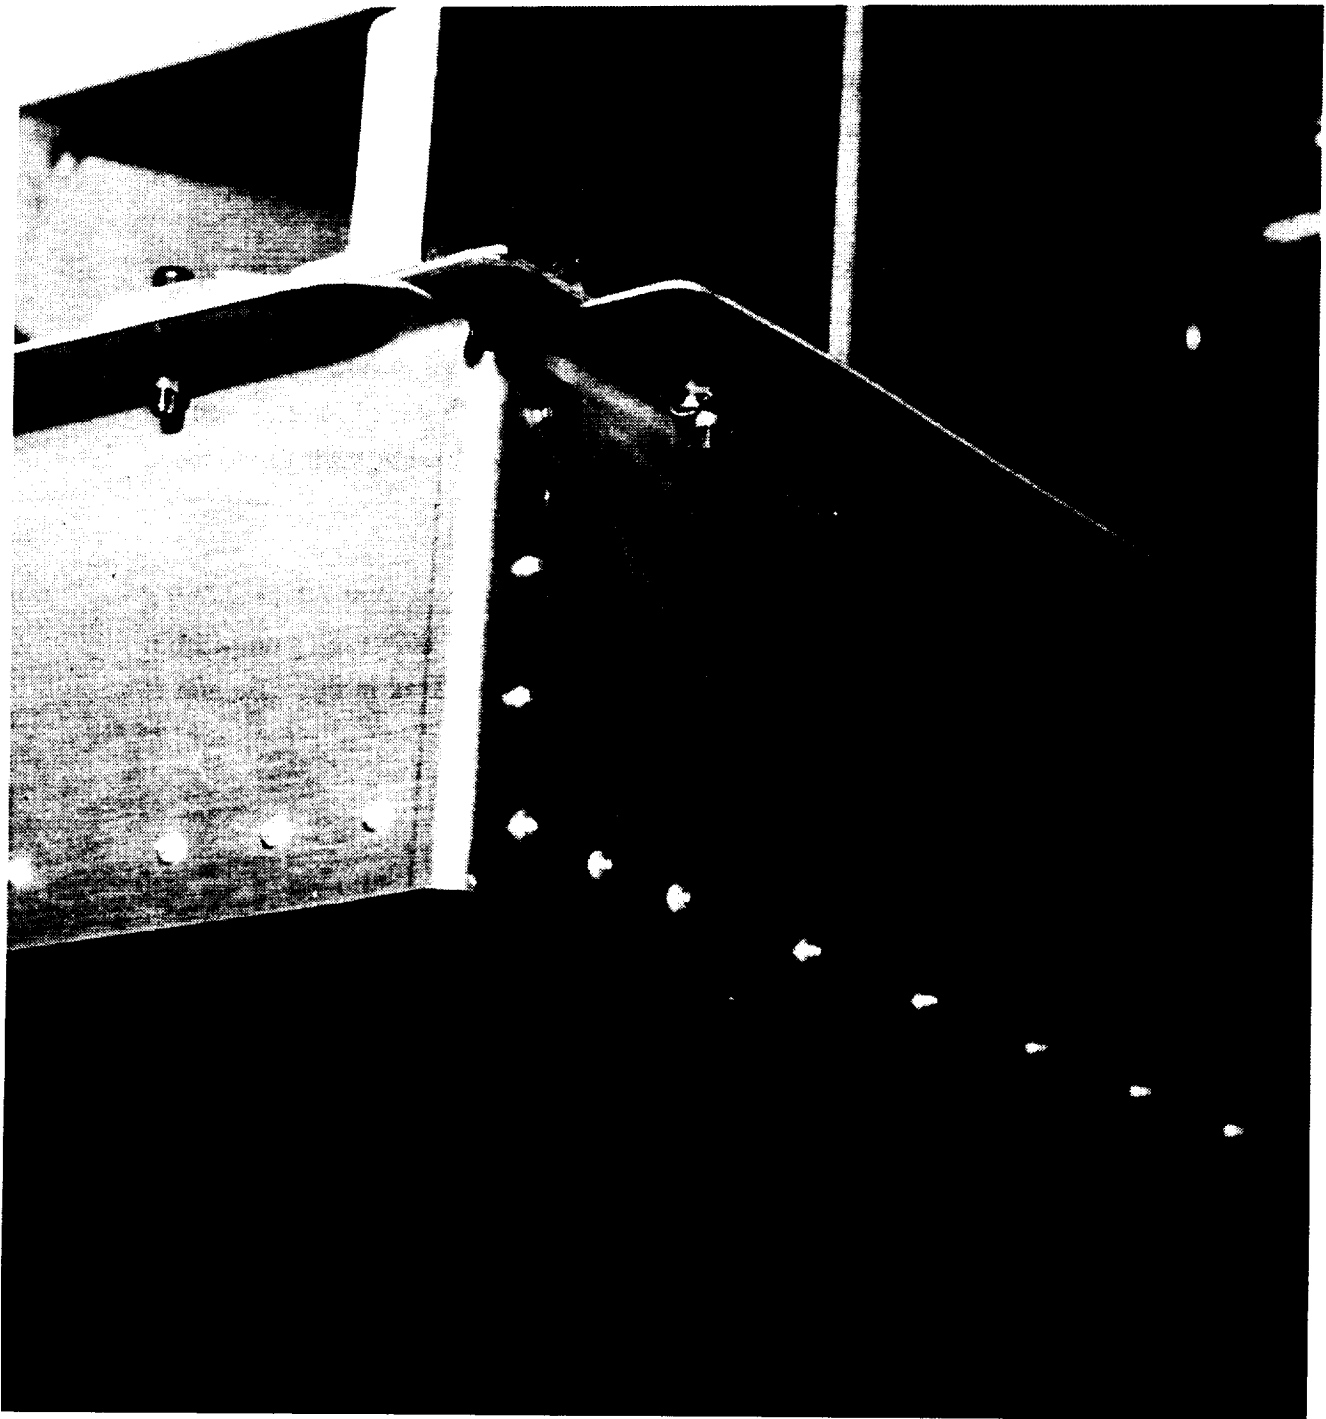
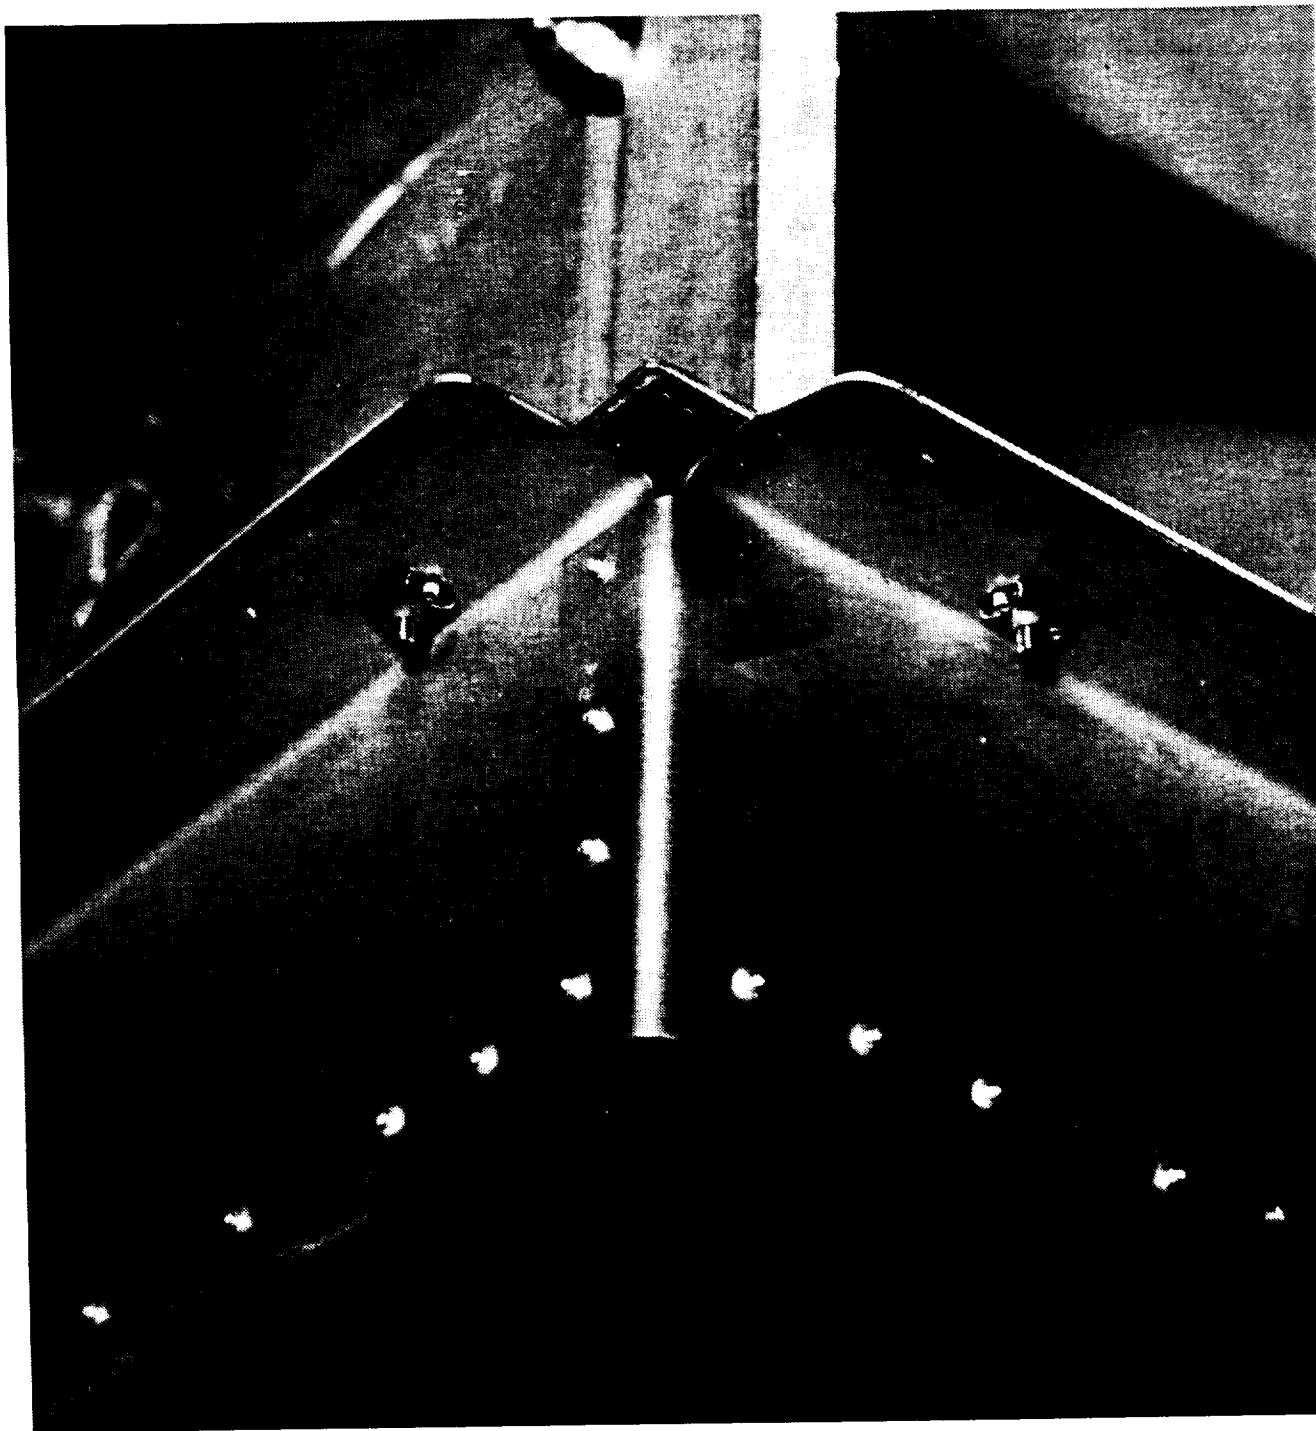
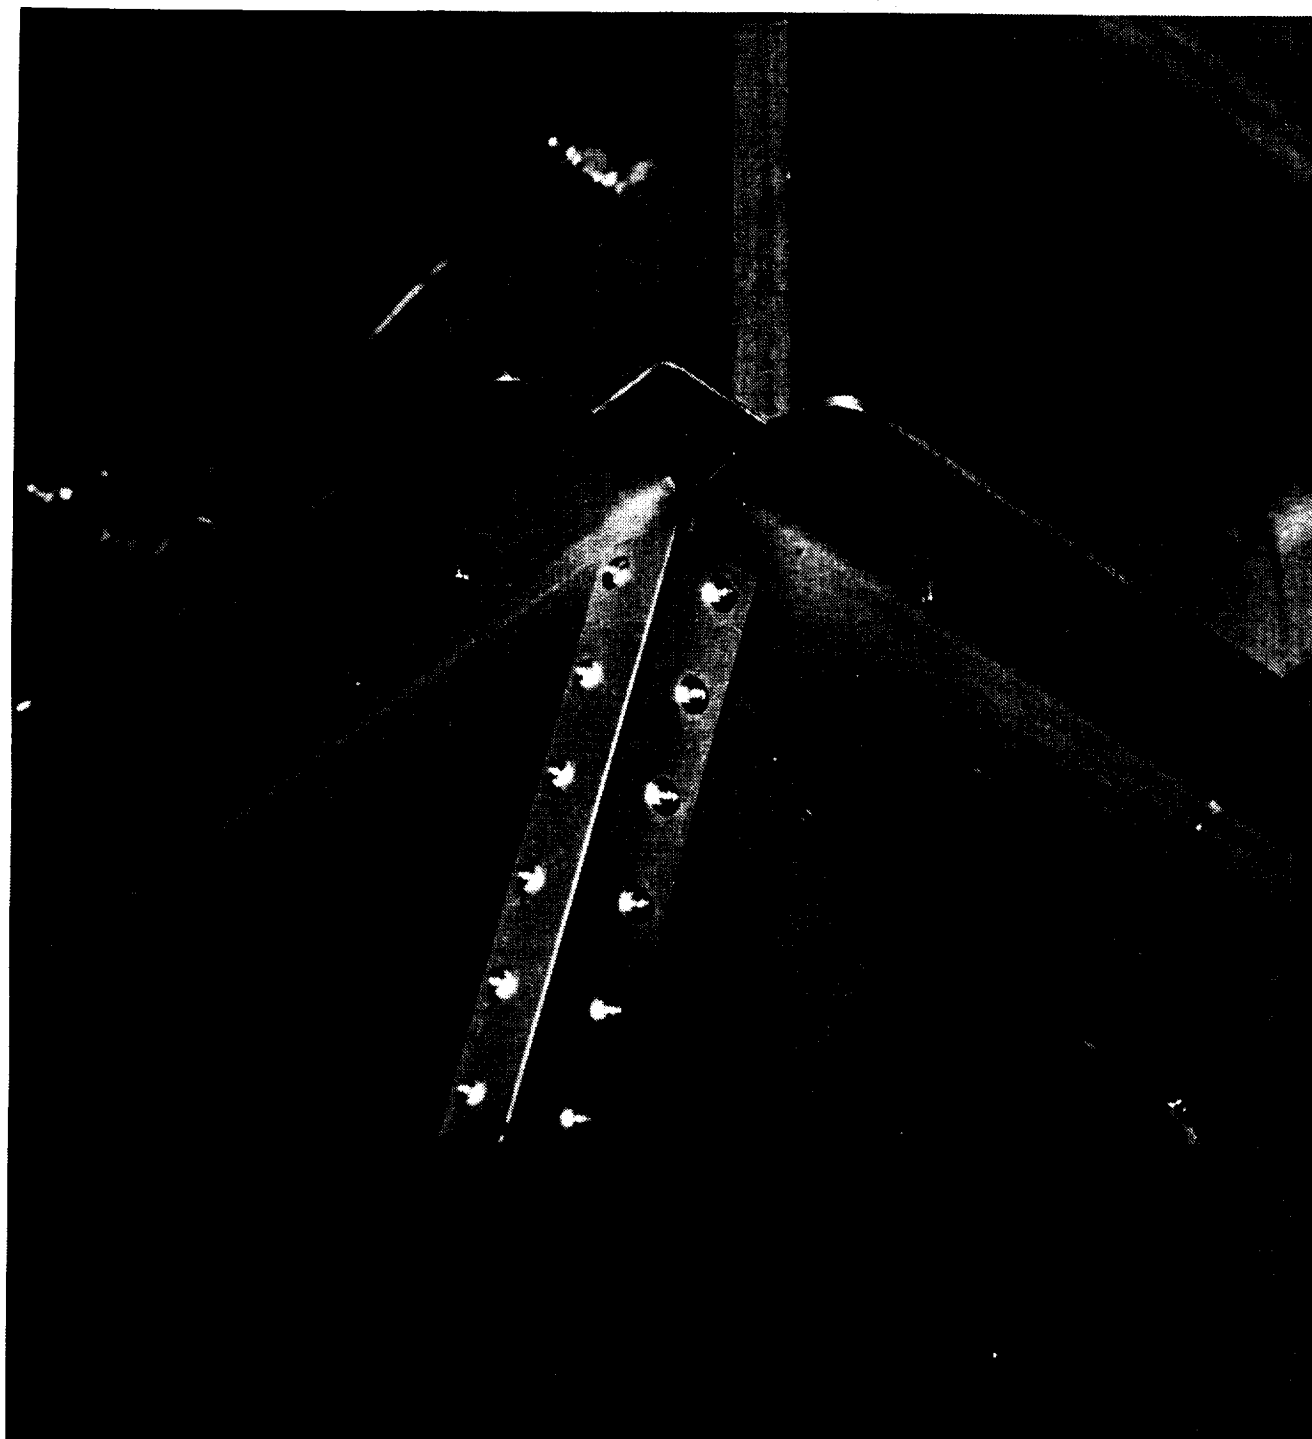
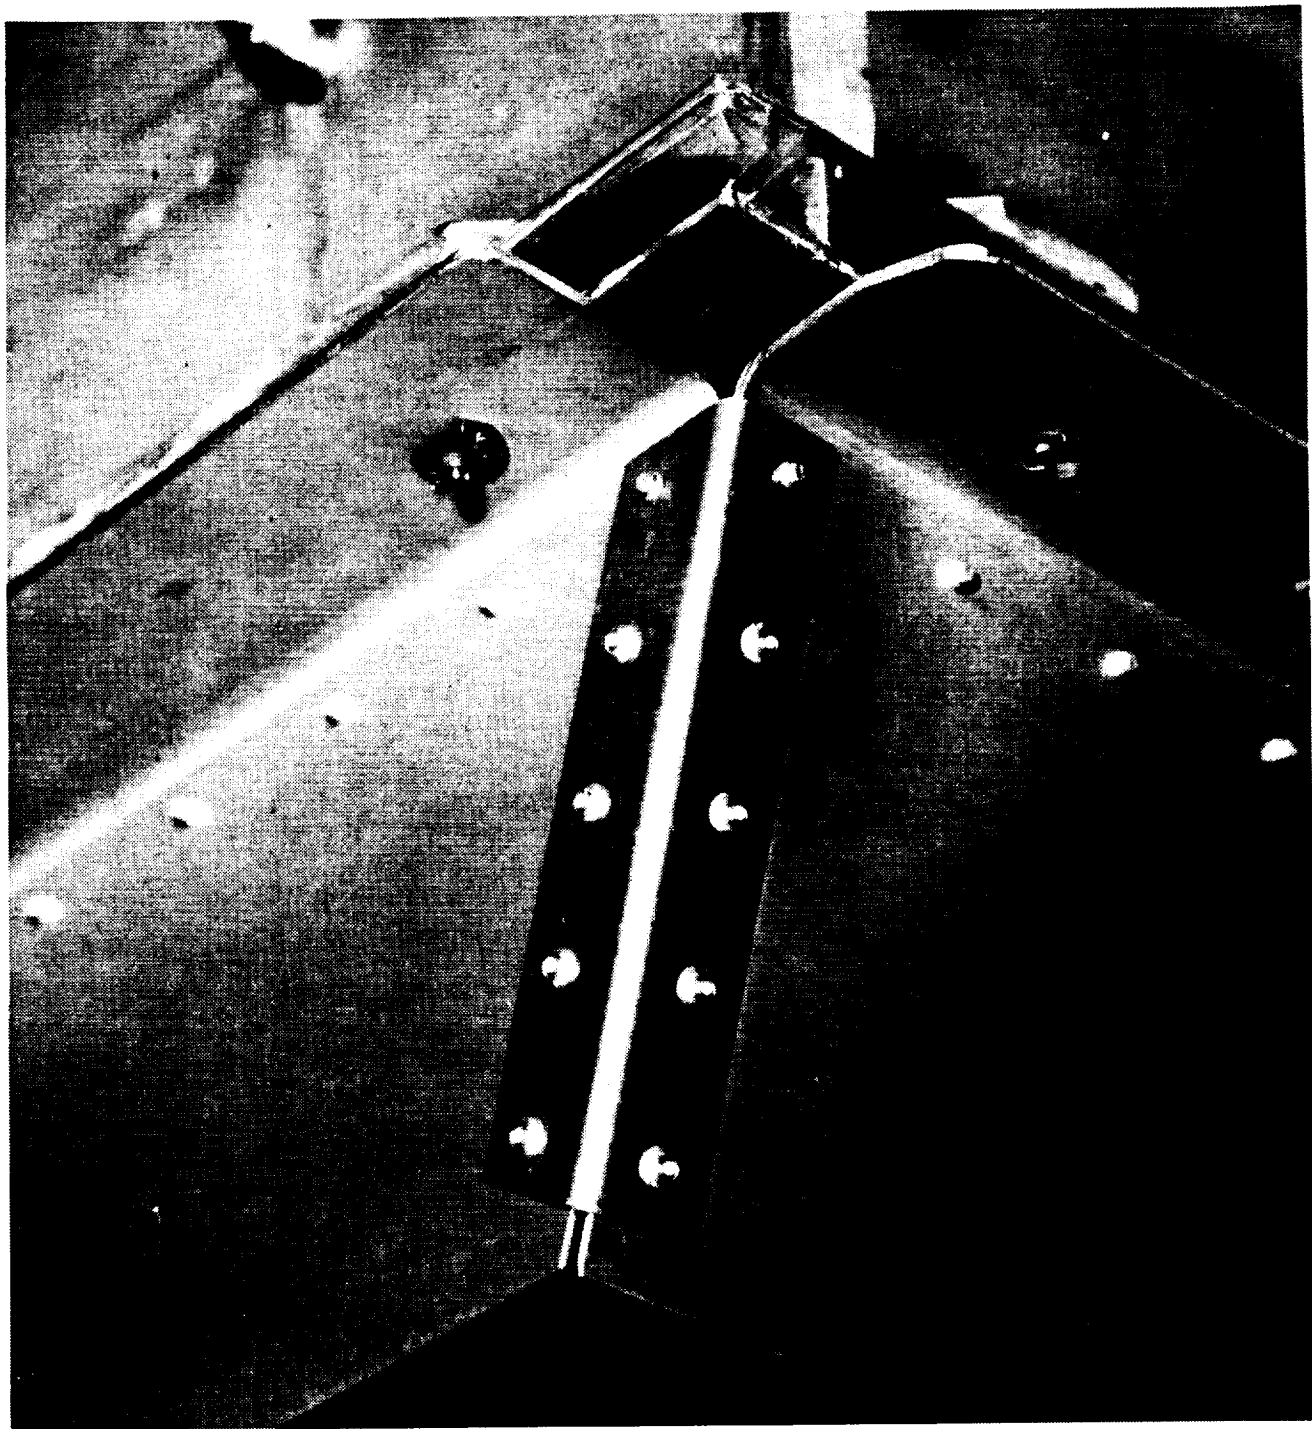
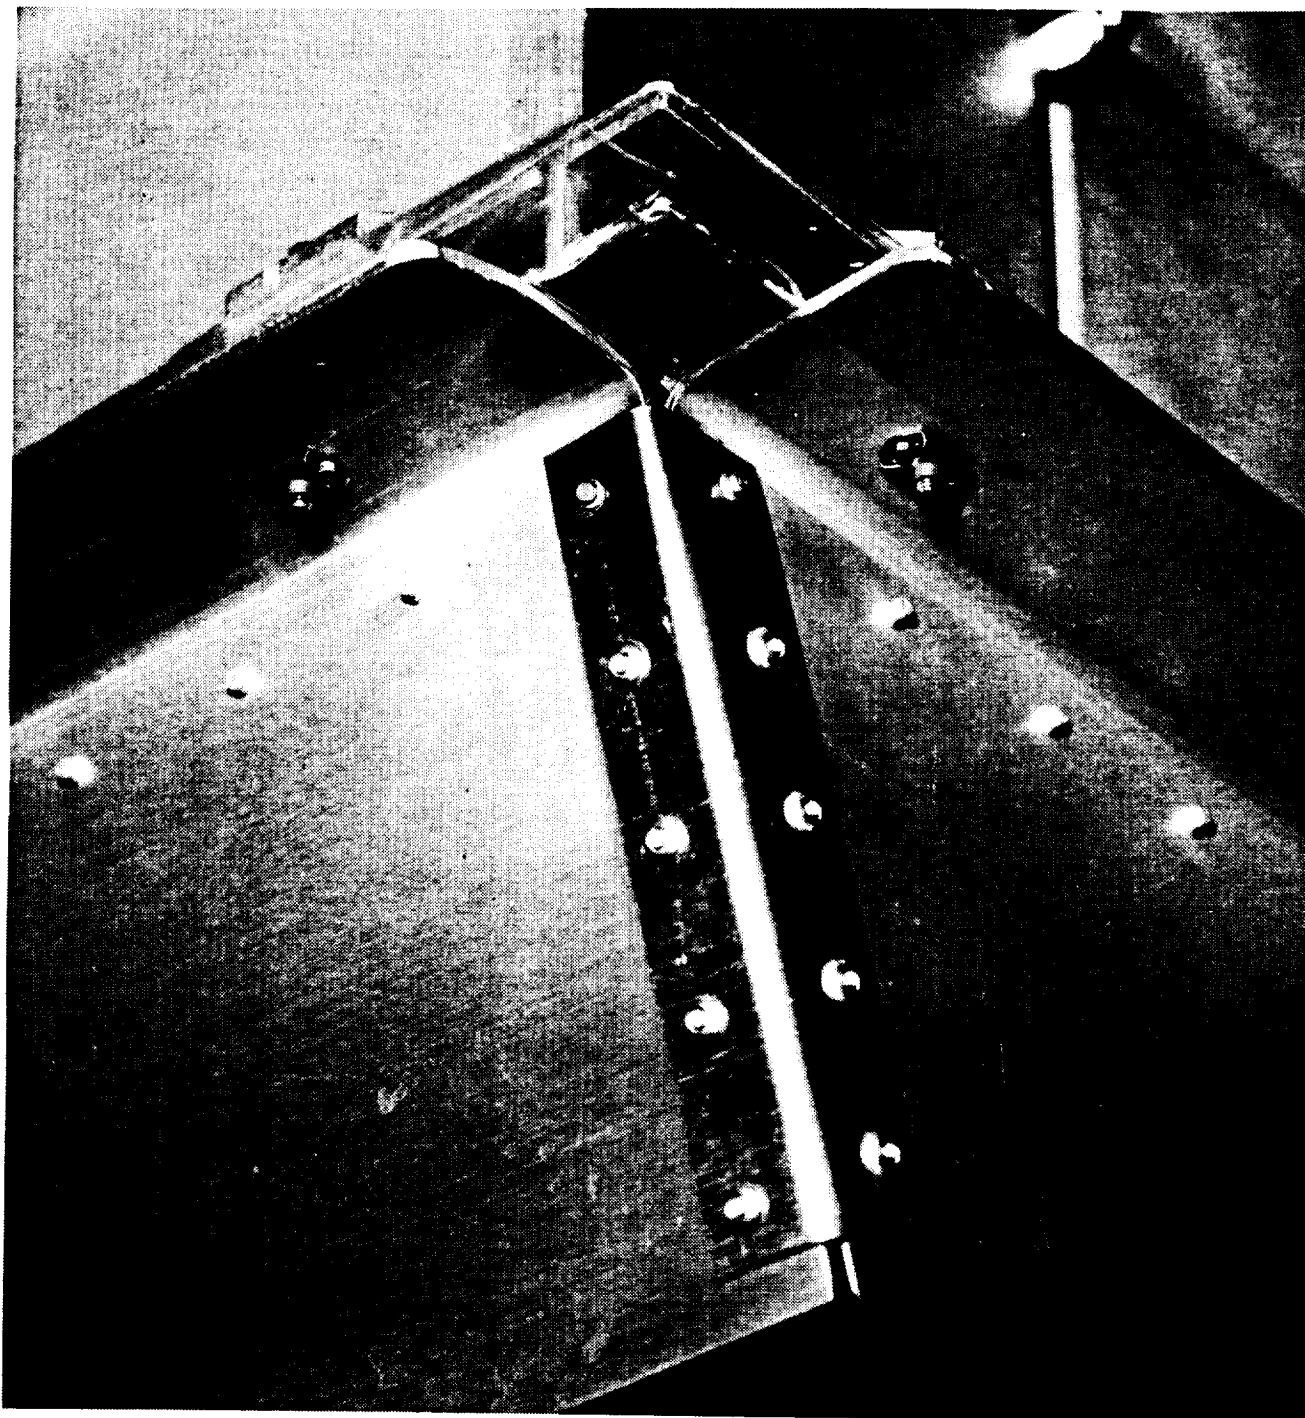
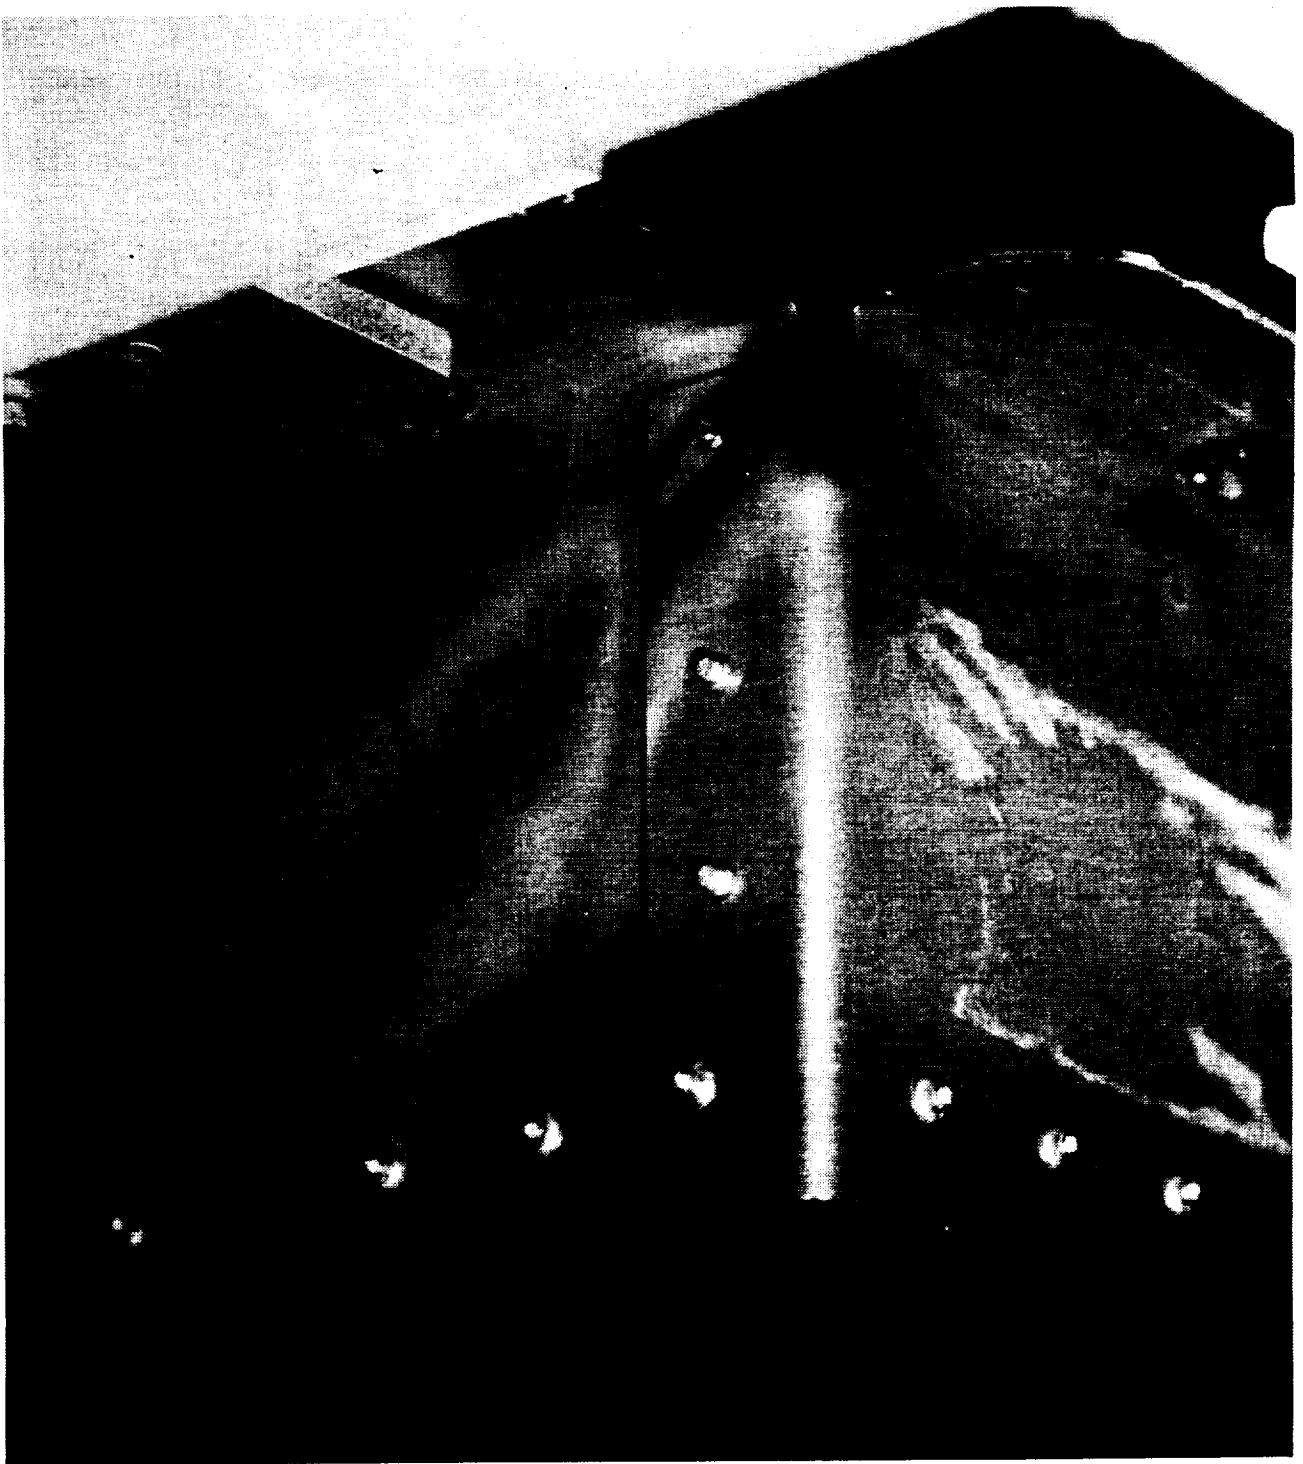
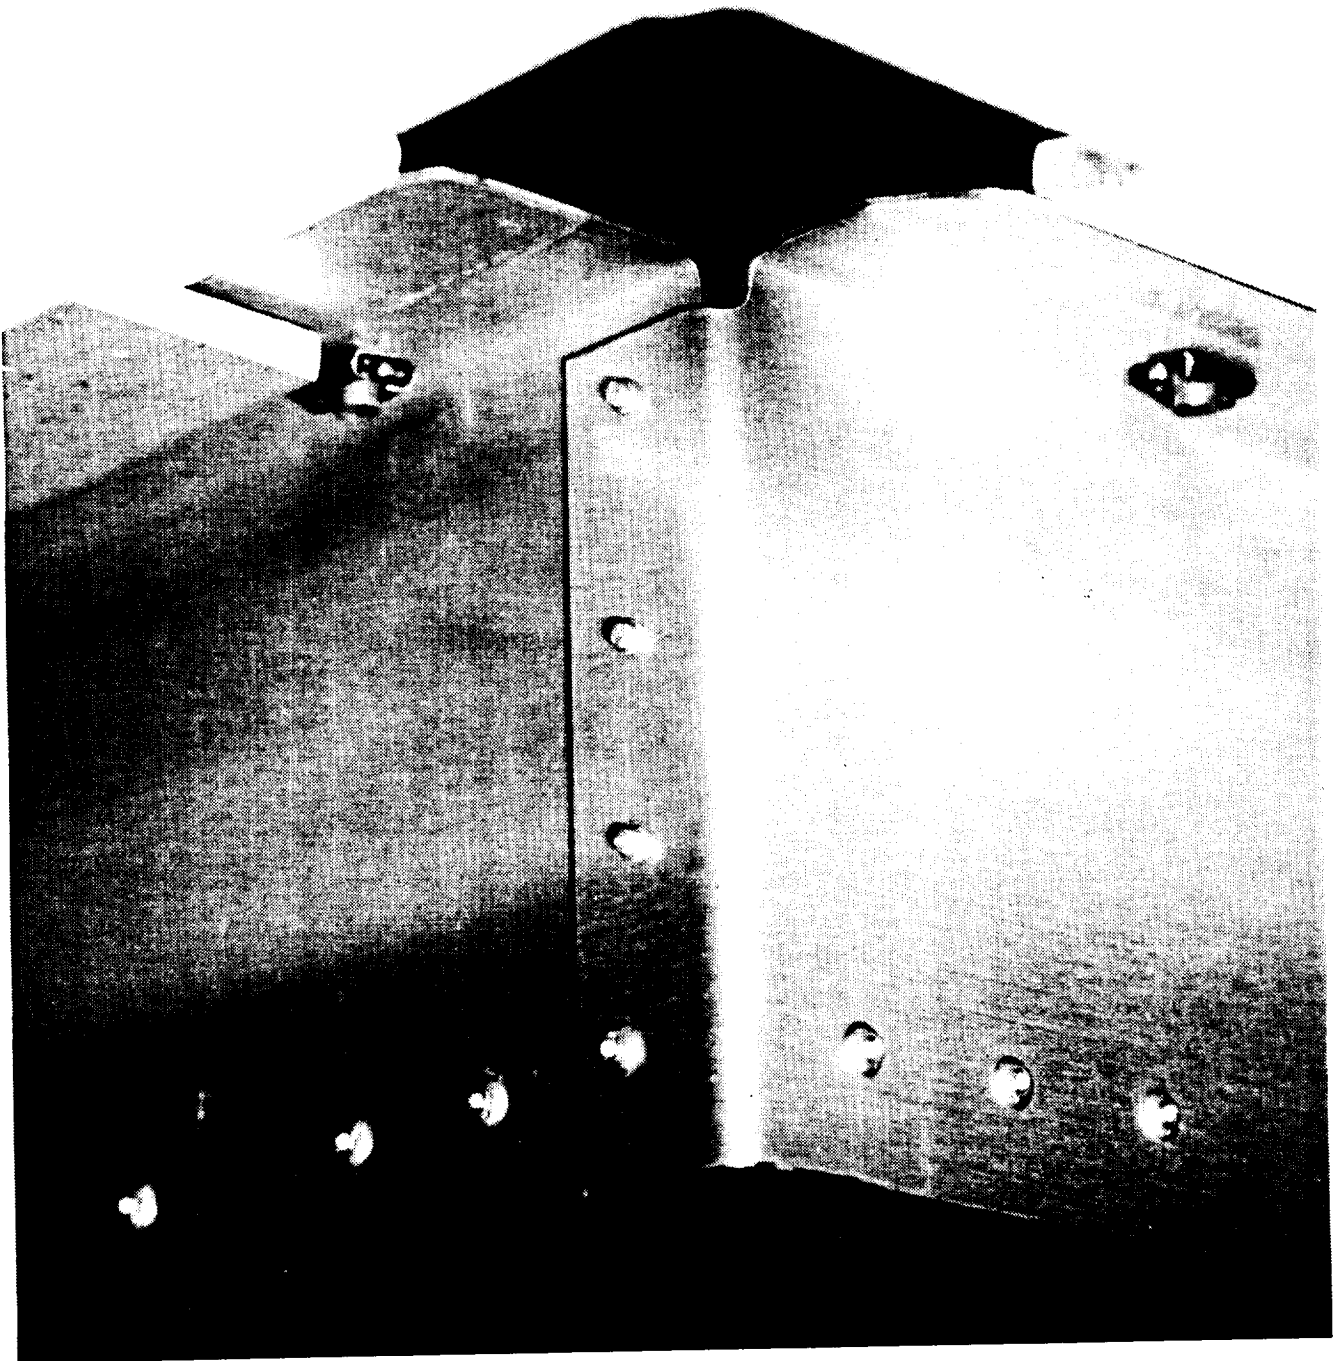
Figures 7.2-6 through 7.2-14 are a series of NASA post-flight photographs showing contamination discoloration patterns due to pre-flight silicone outgassing deposition followed by on-orbit exposure to solar UV. These post-flight photos are all of trays from the leading half of LDEF (rows 7-11). Three of the figures are from tray F11, which contained one of the anodized aluminum thermal balance panels. Only one corner of tray F11 is adjacent to an AO178 tray, but all three corners of the F11 tray show contamination discoloration. Therefore, the source of the darkened contaminated areas is not venting from the AO178 tray. As described in section 6.1, the discolored area of contamination at the tray lips match the width of the tray cover gaskets. It has been suggested that the source of the discoloration on the outside of the trays is outgassed silicone RTV adhesive from experiment AO178. This is not the case. Many of the photographs in figures 7.2-6 through 7.2-14 are taken of corners of trays which were not adjacent to AO178 trays or any other tray which had a source of silicone. The only documented direct exposure to silicone was when the tray covers were in place prior to the flight and after the flight.

These photos support the conclusion that silicone material outgassed from the tray cover gaskets prior to the flight and that solar exposure darkened these surface over time. This issue has not been investigated thoroughly. All these photos are of leading edge trays which were also subject to some atomic oxygen exposure which would have altered the chemical nature of the films. Trailing edge locations did not show such pronounced patterns.
